Land and Water

An Urban Stream Restoration Case Study:

The Northern Virginia Stream Restoration Bank

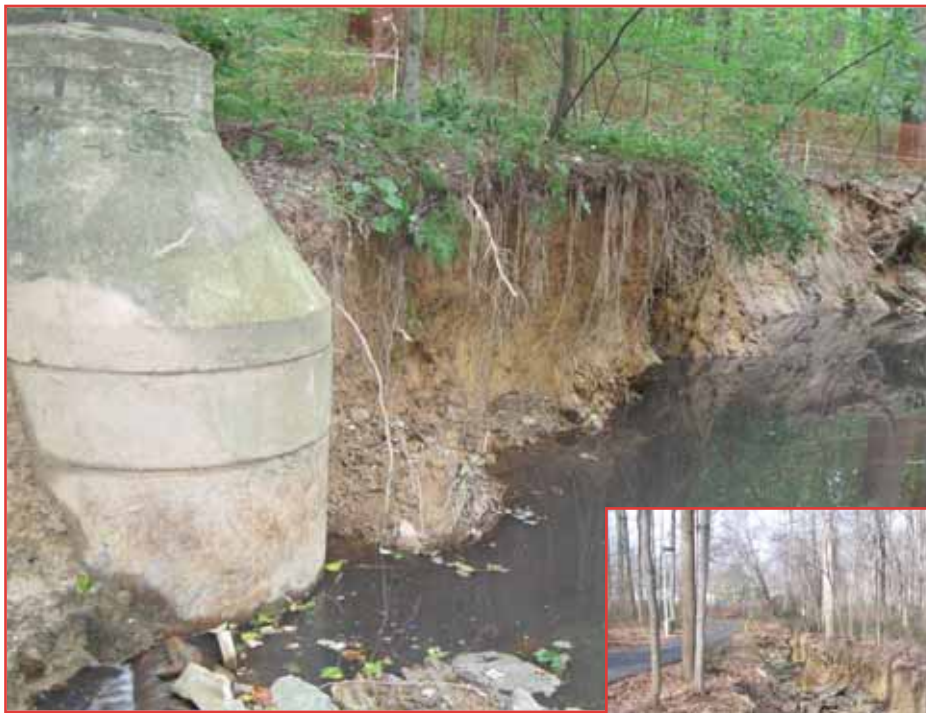
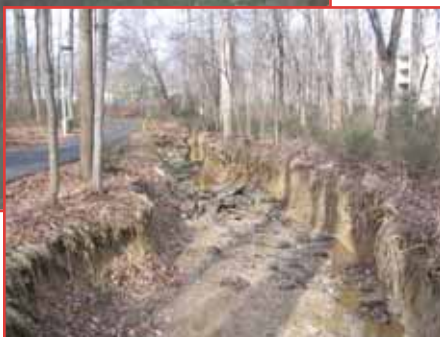
Exposed sanitary manhole within the project area.
Inset: Snakedon Branch before: channel is incised and disconnected floodplain.

Besides the environmental impact of the stream bank erosion and subsequent deposition, degradation of the stream channels has resulted in significant impacts to infrastructure (primarily trails, sewers, and bridges), as well to the immediate riparian areas as the streams incise and become disconnected from the floodplain.

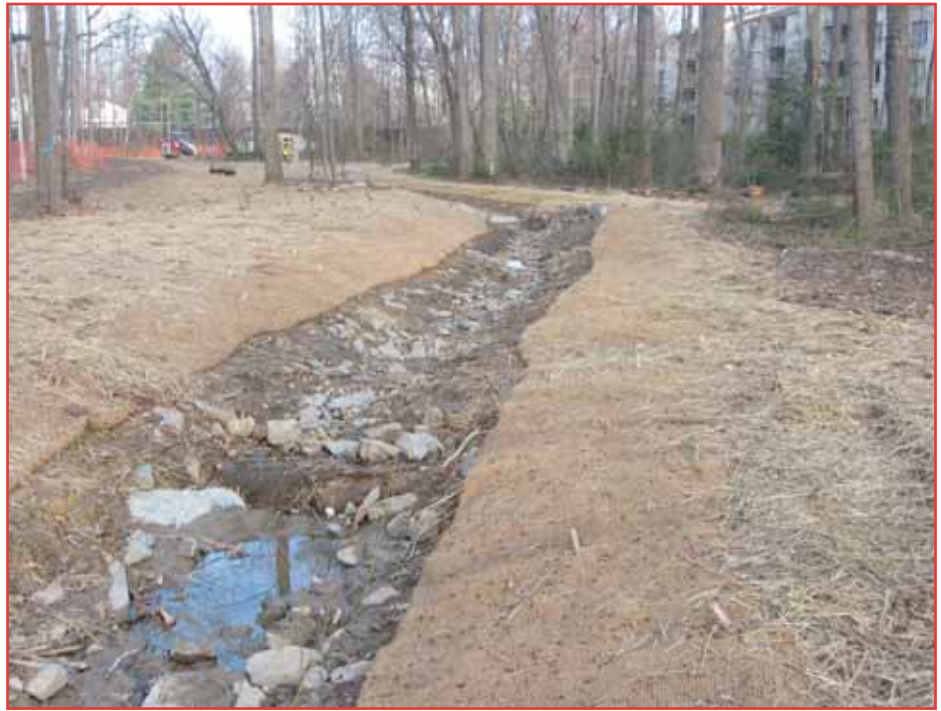
Snakedon Branch post construction: channel is raised to provide floodplain access.

The chosen method for restoring the streams entailed raising the incised channels to re-connect them with the existing floodplain. The alternative approach — and one preferred by some — involved excavating a floodplain at the current incised level of the stream bed. Although this method does provide a firm channel bottom, excavation was not practicable for several reasons. First, utilities run adjacent to and crisscross the stream valley and floodplain and, therefore, would require relocation. Second, excavation of a floodplain would have required removing significantly more trees from within the narrow, wooded stream valleys, an outcome that would not have been acceptable to the community. Lastly, excavation would have necessitated the removal and disposal of massive quantities of soil at significant additional expense. Thus, the decision to raise the channels rather than lower the floodplain was an easy one.

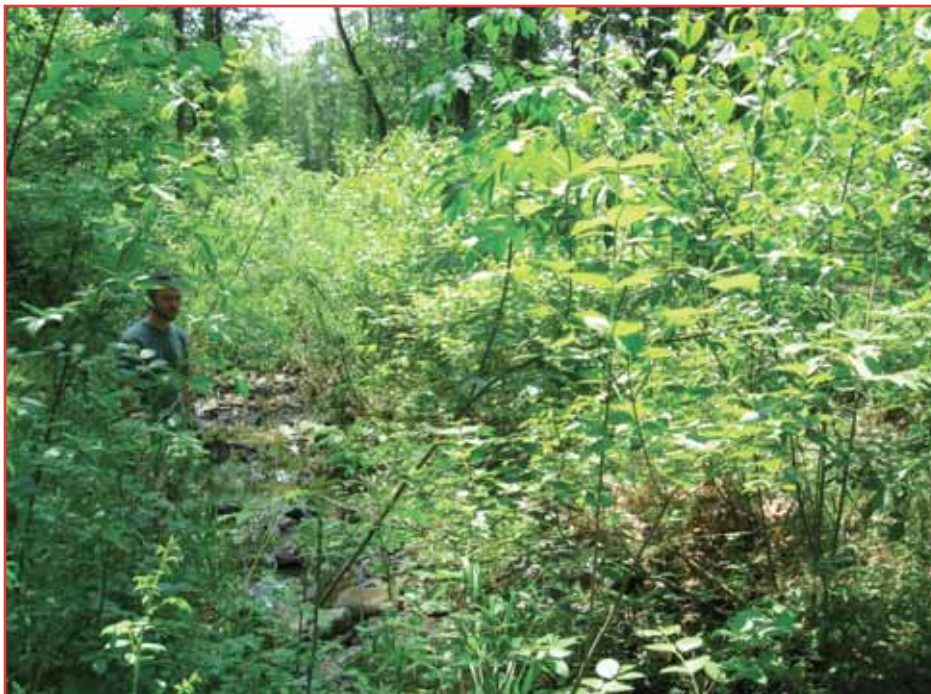
Snakedon Branch 3 years after construction: hearty vegetation has returned along the channel.

toration project is planting. All disturbed areas are over-seeded with a riparian seed mix that contains dozens of native species, including 6 grass, 21 forb, 5 shrub, and 5 tree species. In addition, native trees and shrubs (8 tree and 10 shrub species) are planted in appropriate hydrologic zones in the form of tubelings (streamside) and 1-gallon container grown materials. The successful establishment of a healthy and diverse riparian corridor is attributed not only to the diversity of the planting palette, but also to the heavy seeding and planting densities at which it is applied.

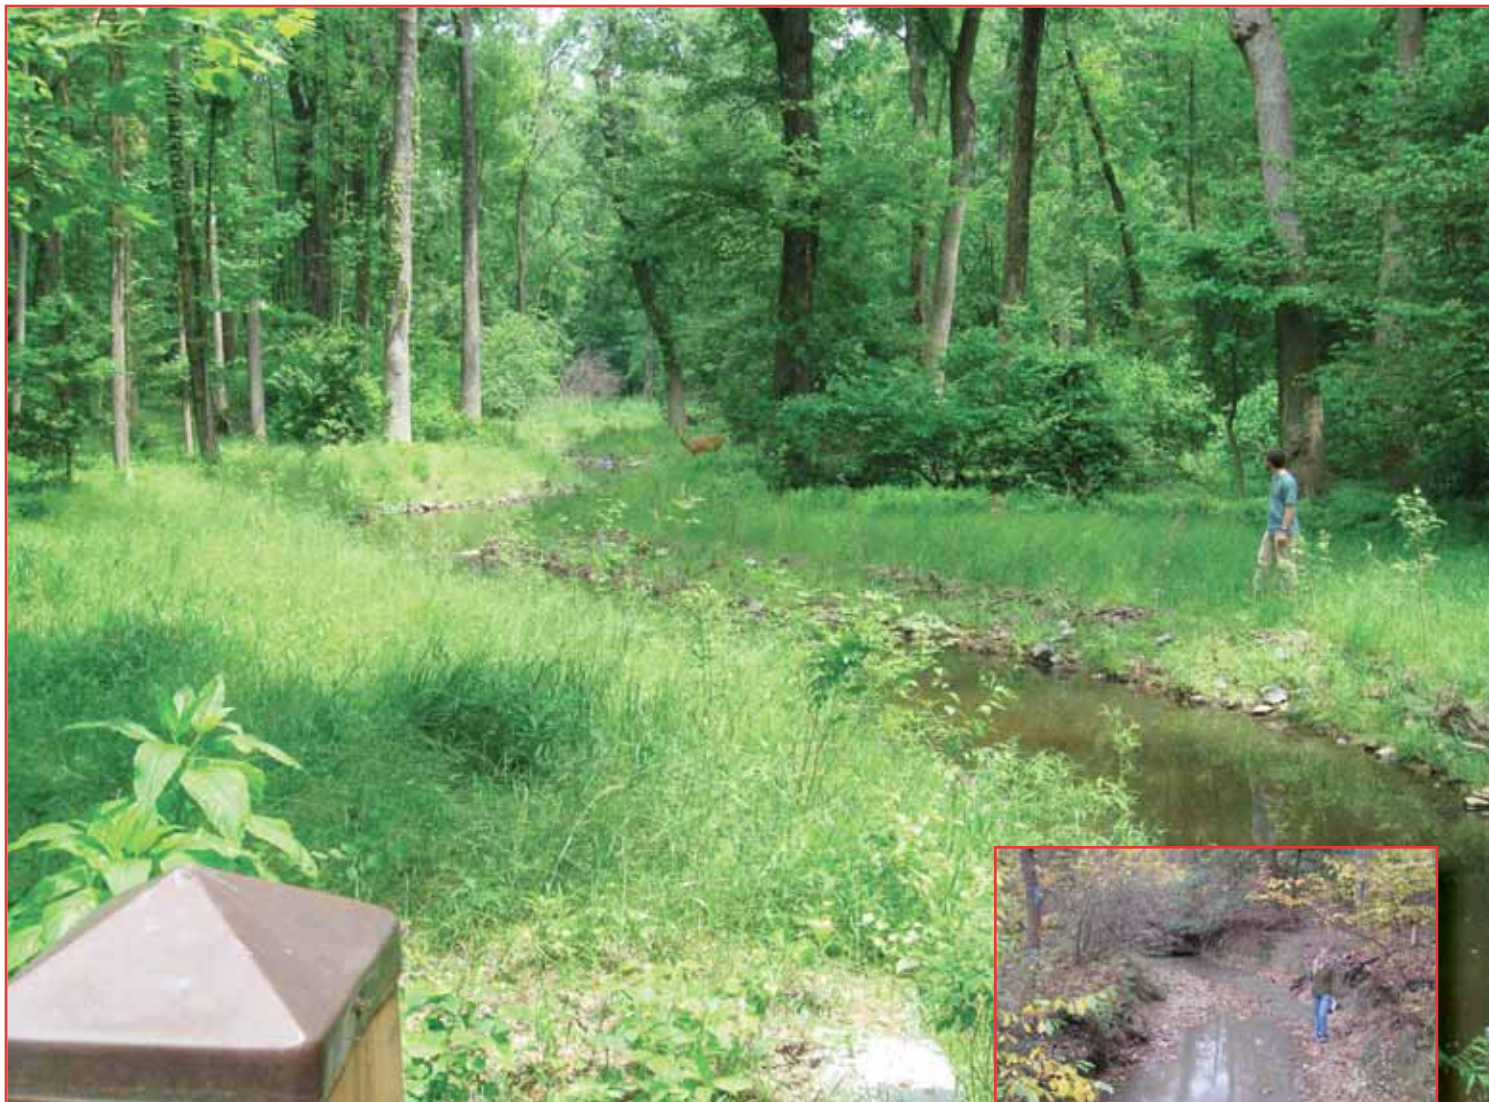
The Glade 1 year post construction. Inset: The Glade pre construction.

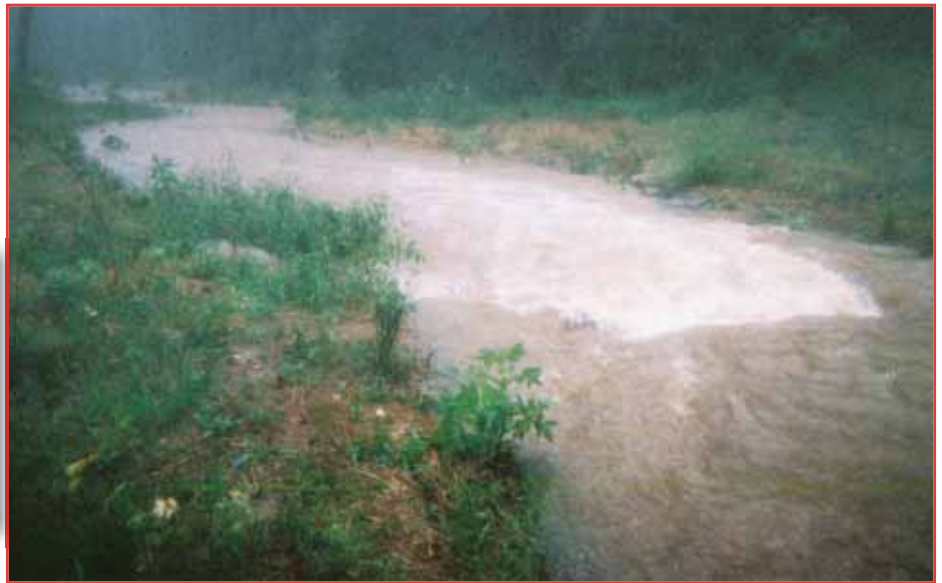
Flooding during Tropical Storm Hannah (6.2” of rain in 9 hours).

Thus far, the NVSRB has been extremely successful. All as-built and monitoring criteria have been met and exceeded since the first reaches were completed in March 2008. The completed streams have successfully handled several significant storm events, including tropical storm Hannah (which was a 100-year event) in 2008, and more recent back-to-back storms - hurricane Irene and tropical storm Lee (tropical storm Lee was classified between a 200 and 500-year storm event) in 2011. Overall, the restored stream channels performed very well. The reaches with more mature vegetation handled the flooding with no issues, while some of the recently constructed reaches required minor repairs. This result was expected, because the tree and shrub roots had not yet had time to reinforce the soil. WSSI and RA staff performed post-storm inspections, and crews were mobilized immediately to conduct the minor repairs.

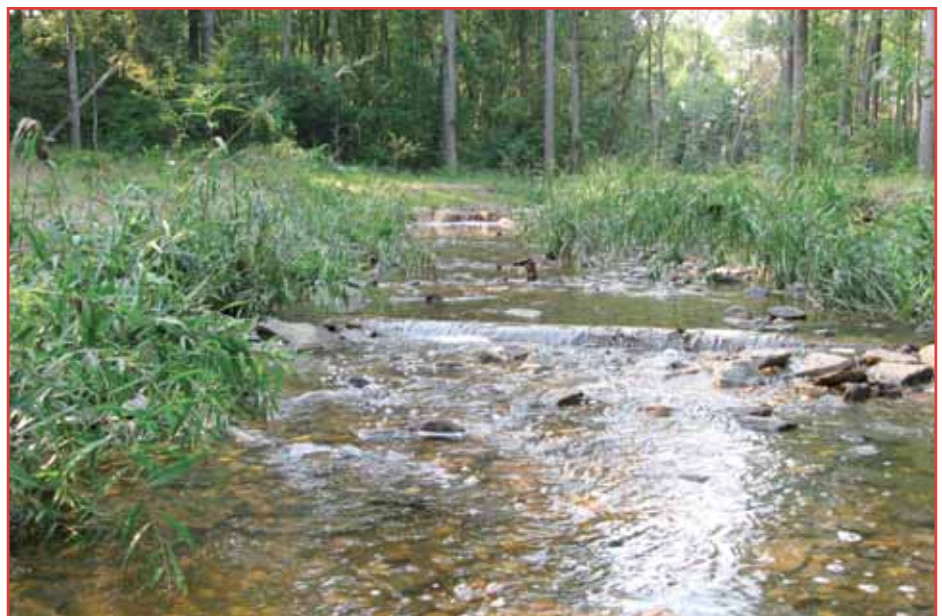
Stream conditions two days after Tropical Storm Hannah.
