# UNIFIED STREAM METHODOLOGY

### 1.1.2 Channel Condition Photographs

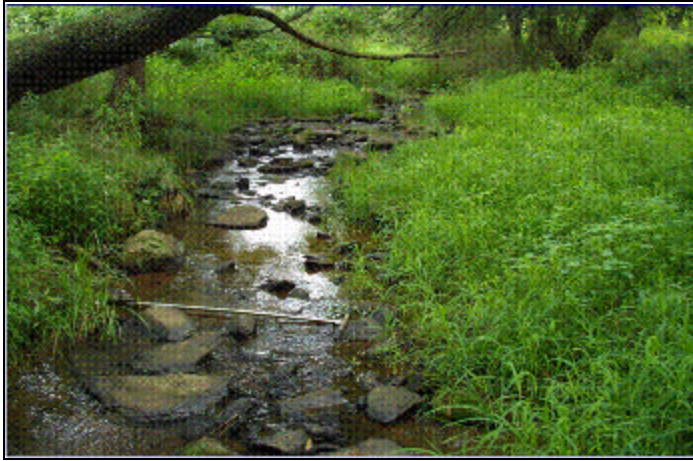
**Optimal Channel Condition:** This channel is stable with bankfull benches and has access to its floodplain.

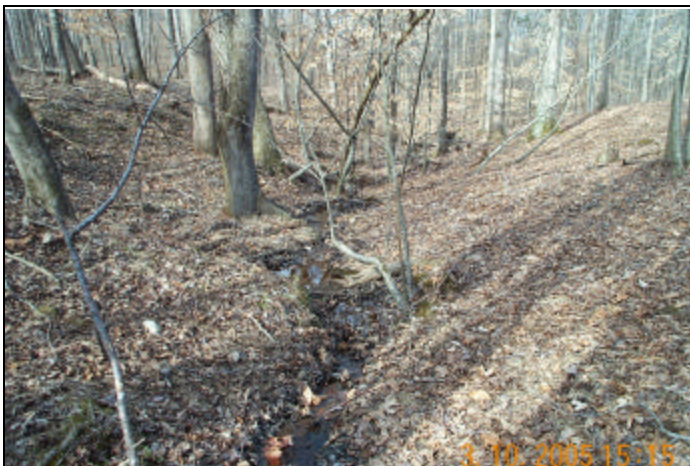
**Optimal Channel Condition:** This channel has little or no incision and /or unprotected banks along both banks.

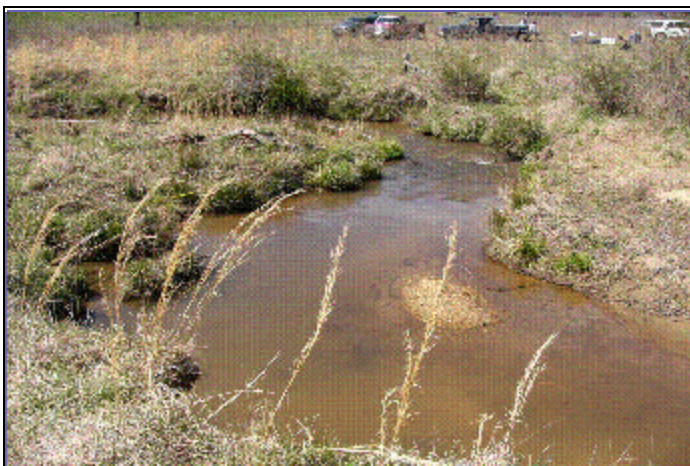
**Suboptimal Channel Condition:** Depositional features are present and most appear to be contributing to stability. This stream has access to bankfull benches, or newly developed floodplains along portions of the reach.

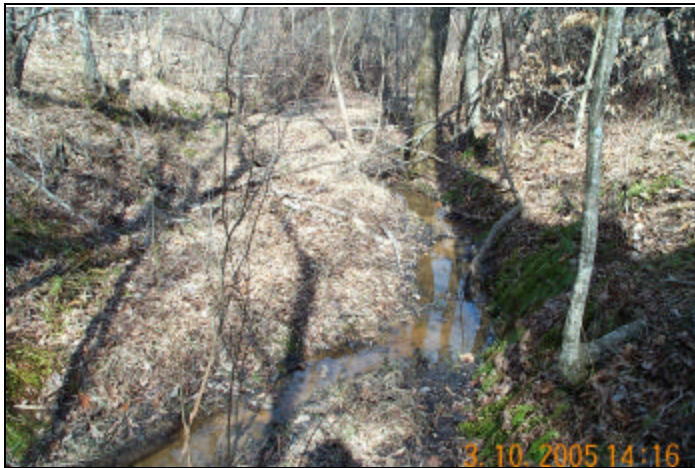
**Suboptimal Channel Condition:** The majority of both banks are stable. Vegetative surface protection is prominent along 60-80% of the banks.

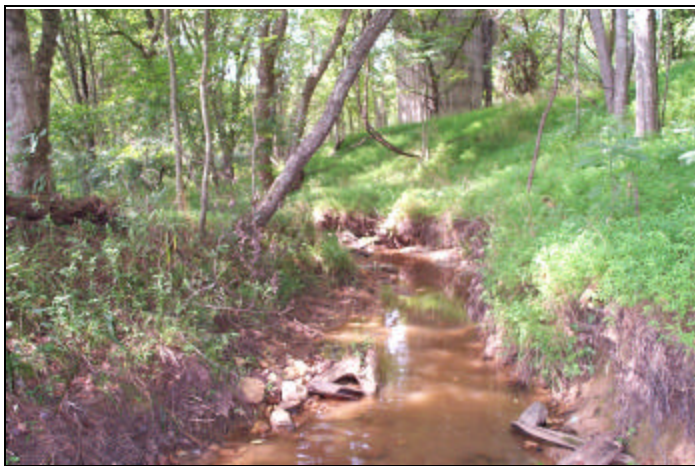
**Marginal Channel Condition:** This channel is incised, but to a lesser degree than a *Severe* or *Poor* channel condition.

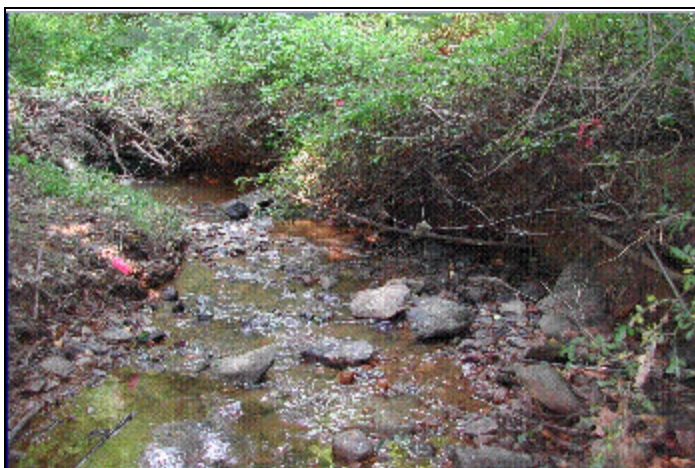
**Marginal Channel Condition:** The stream has some vertical banks, but other portions have begun to narrow. The streambed has substantial sediment deposition.

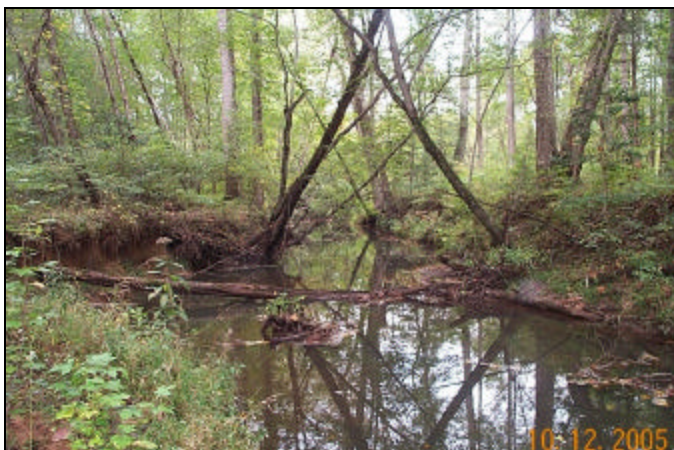
**Poor Channel Condition:** This channel is incised and appears to be widening rather than down cutting.

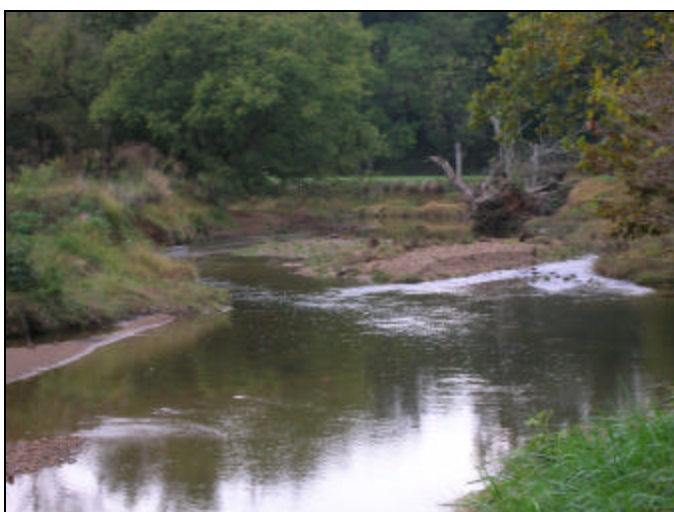
**Poor Channel Condition:** This channel is aggrading and has an excessive sediment supply that is filling the channel with alluvium.

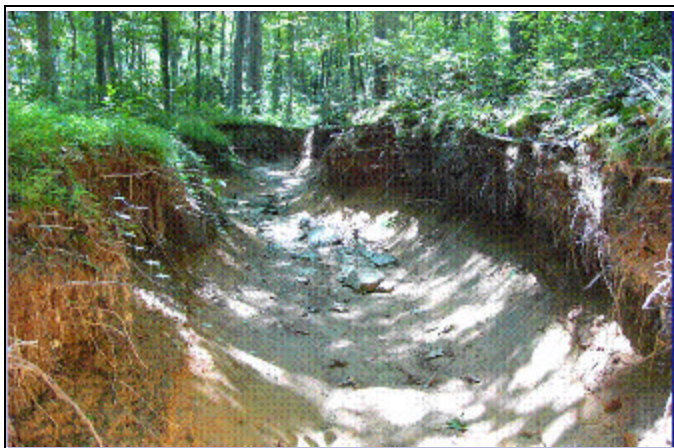
**Severe Channel Condition:** This channel is deeply incised and vertically and laterally unstable.

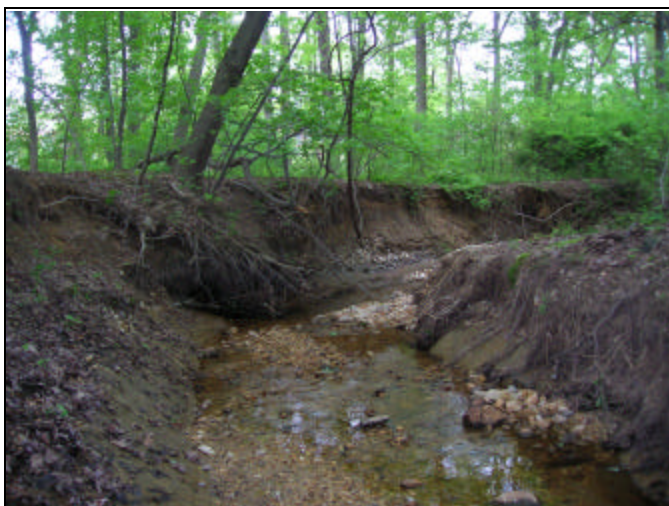
**Severe Channel Condition:** This channel is deeply incised and vertically and laterally unstable.

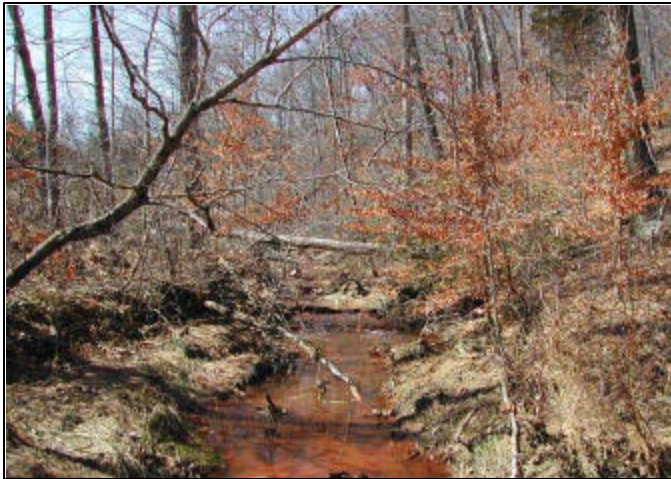
**Optimal Riparian Buffer Category:**  
The riparian buffer has a tree stratum (dbh > 3 inches) present with > 60% tree canopy cover.

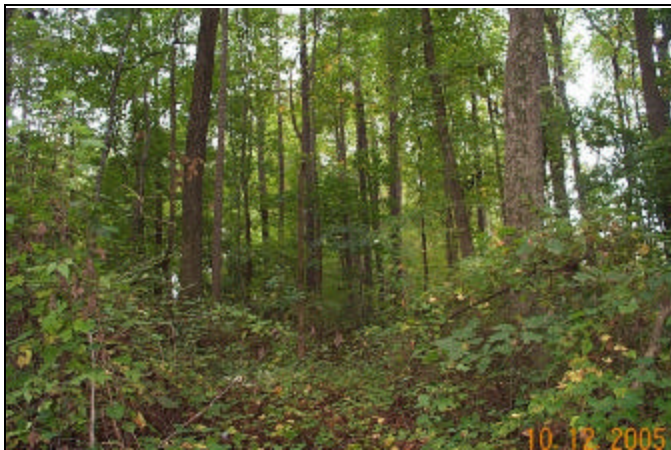
**Optimal Riparian Buffer Category:**  
The riparian buffer has a tree stratum (dbh > 3 inches) present with > 60% tree canopy cover.

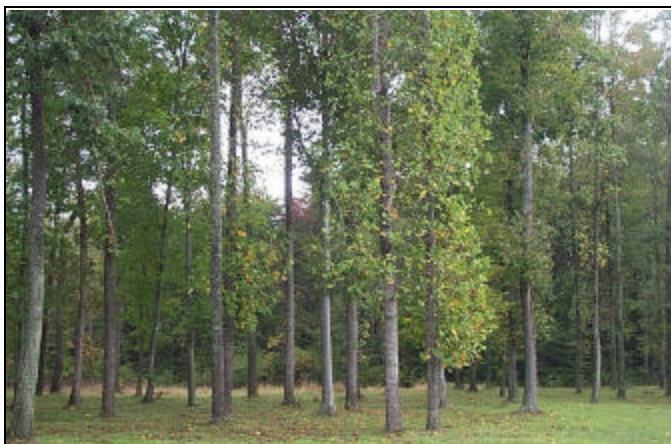
**Optimal Riparian Buffer Category:**  
The riparian buffer has a tree stratum (dbh > 3 inches) present with > 60% tree canopy cover.

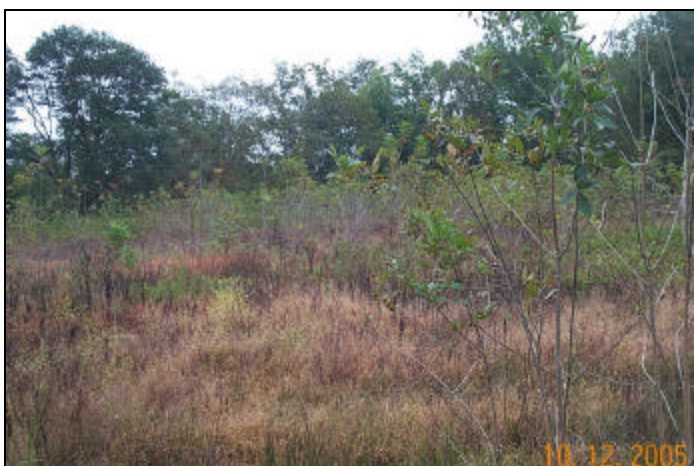
**High Marginal:** The riparian buffer is nonmaintained, dense herbaceous vegetation with a shrub layer.

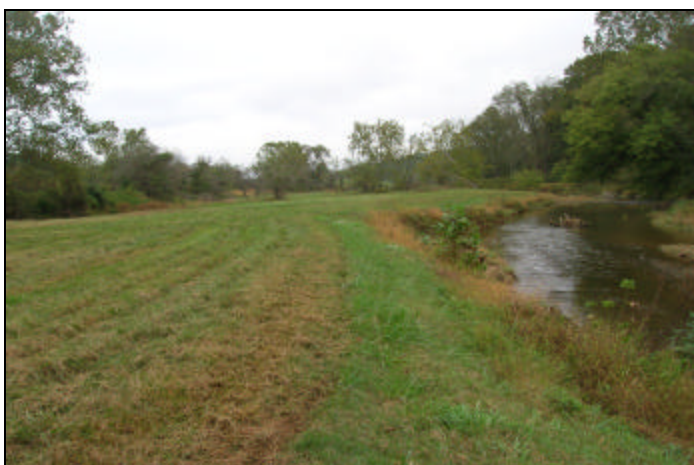
**High Poor:** The riparian buffer is mowed and maintained area.

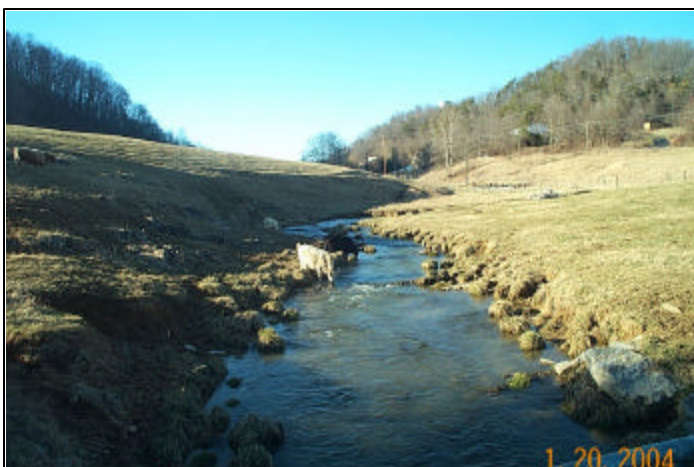
**High Poor:** The riparian buffer is a grazed pasture area.

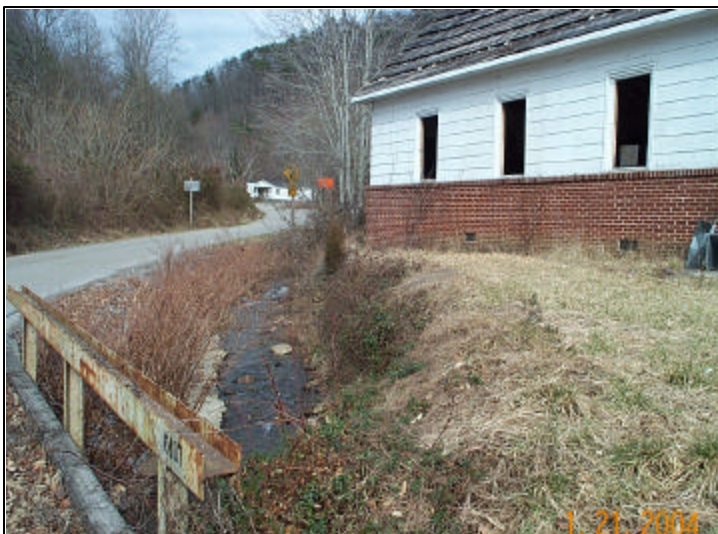
**Low Poor:** The riparian buffer has a building and roadway located within it. The building and roadway score low poor.

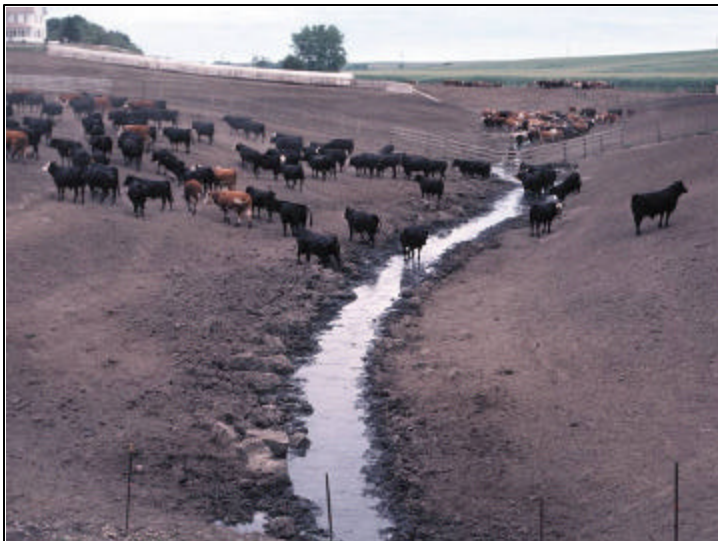
**Low Poor:** The riparian buffer is an active feed lot and /or denuded area.

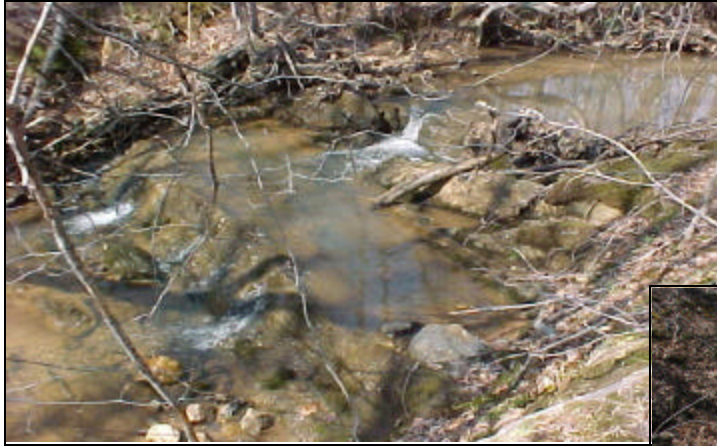
**Optimal:** Physical elements that enhance a high gradient stream's ability to support aquatic organisms are present in greater than 50% of the reach.

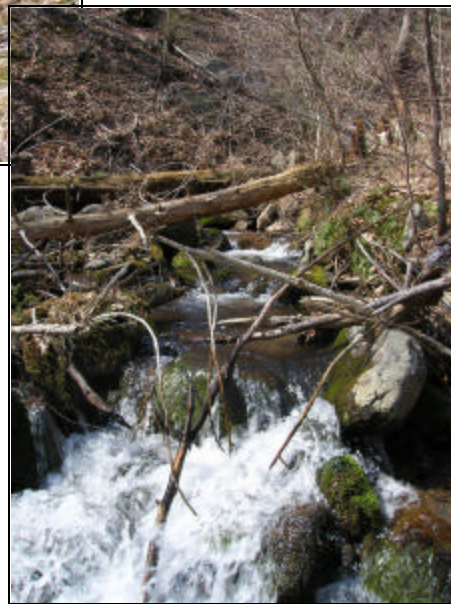
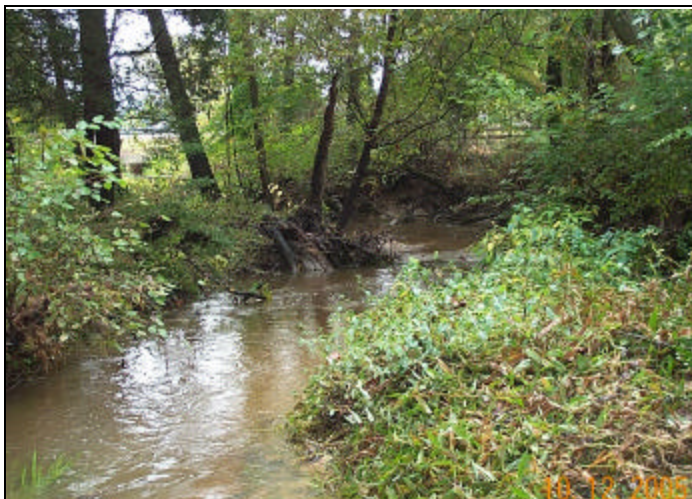
**Suboptimal:** Physical elements that enhance a stream's ability to support aquatic organisms are present in 30-50% of the reach.

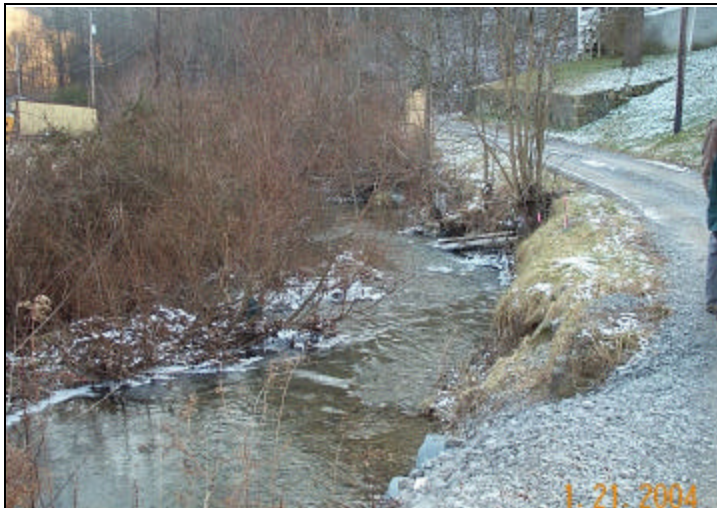
**Suboptimal:** Physical elements that enhance a stream's ability to support aquatic organisms are present in 30-50% of the reach.

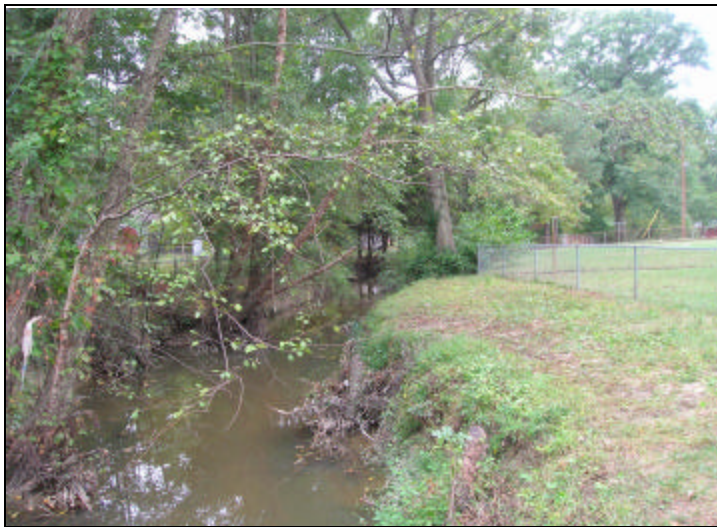
**Marginal:** Physical elements that enhance a stream's ability to support aquatic organisms are only present in 10-30% of this low gradient reach. The pool substrate is composed of mud, sand, or clay.

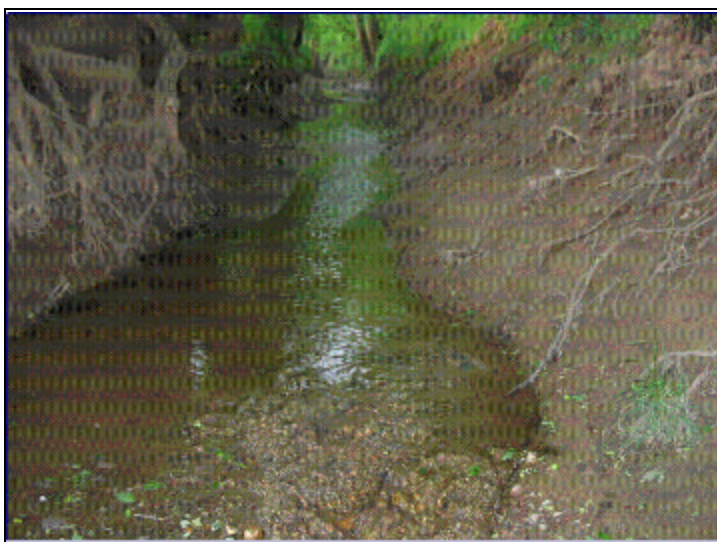
**Poor:** Physical elements that enhance a stream's ability to support aquatic organisms is present in less than 10% of this reach. The substrate is homogeneous and has little variability.

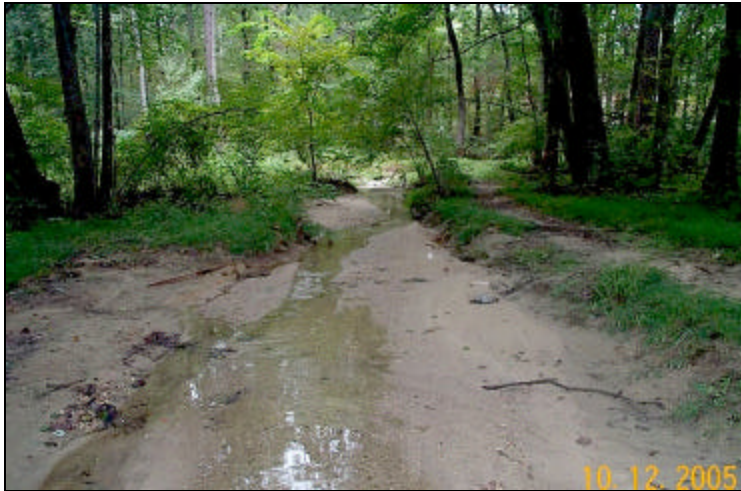
**Poor:** Physical Elements that enhance a stream's ability to support aquatic organisms is present in less than 10% of this reach. The substrate is homogeneous.

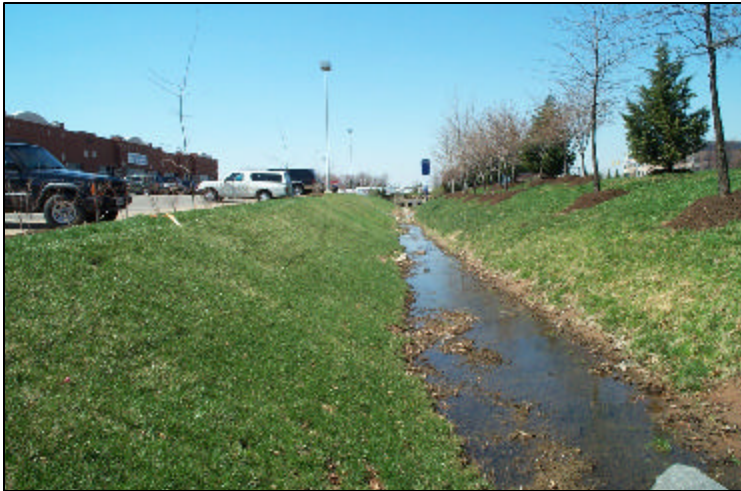
Straightening of channel or other channelization.

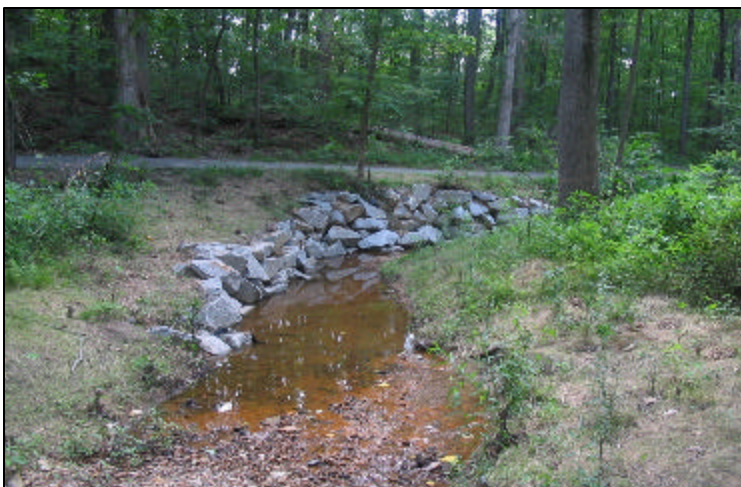
Riprap along streambank or in streambed.

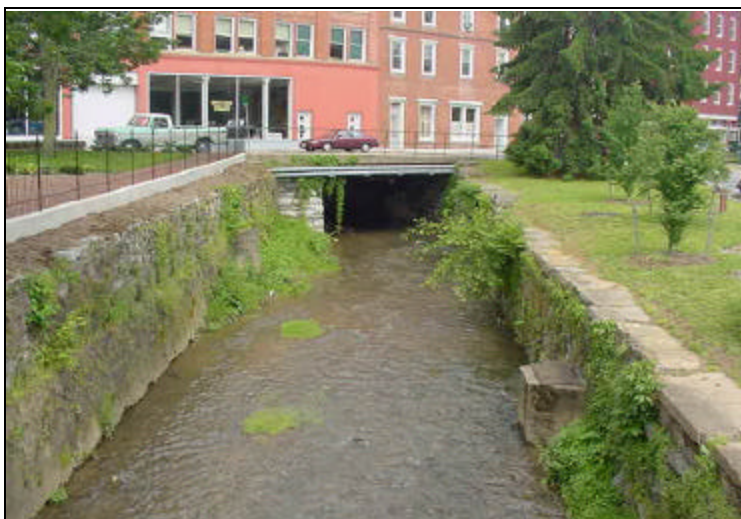
Straightening of Channel, Channelization, Constriction, and constrictions to stream channel or immediate flood prone area.

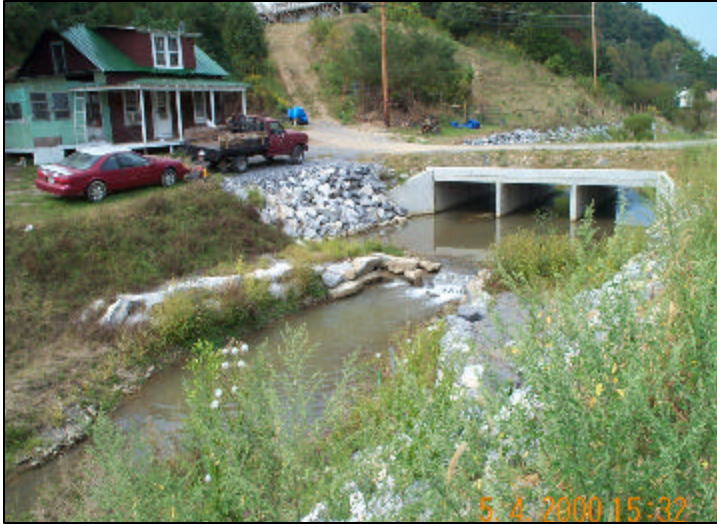
Stream crossings (bridges and bottomless culverts) and constrictions to stream channel or immediate flood prone area.

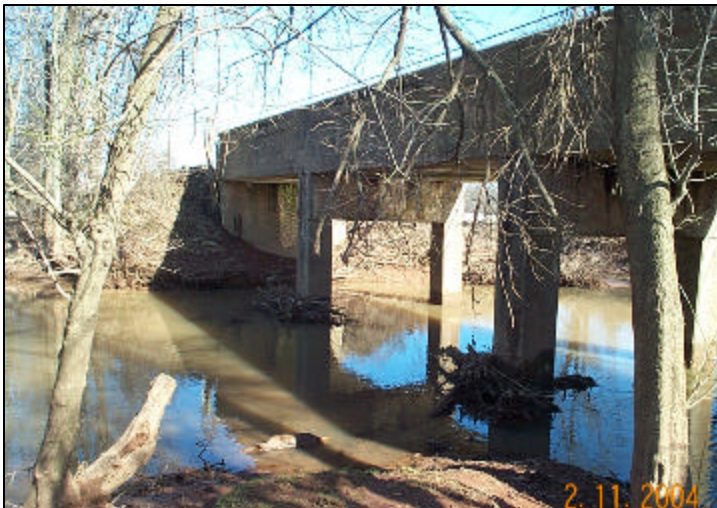
Stream crossings (bridges and bottomless culverts).

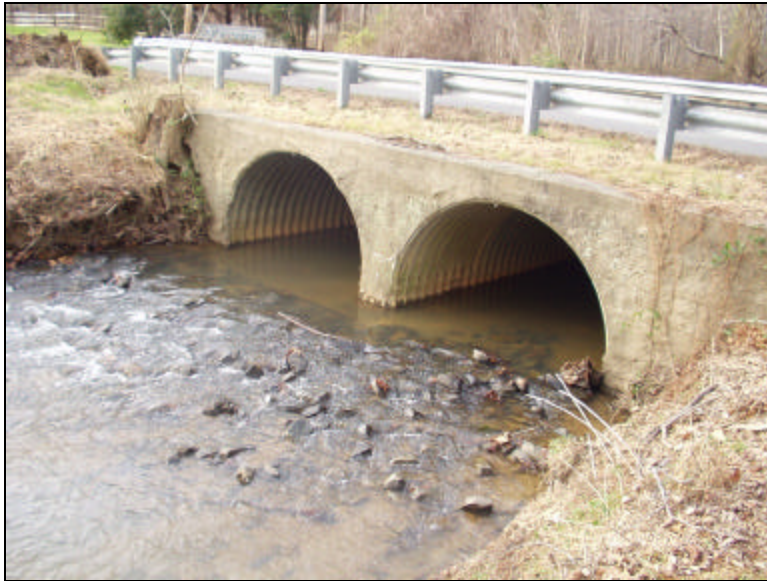
**Severe:** Twin Arch Culverts with concrete bottom.

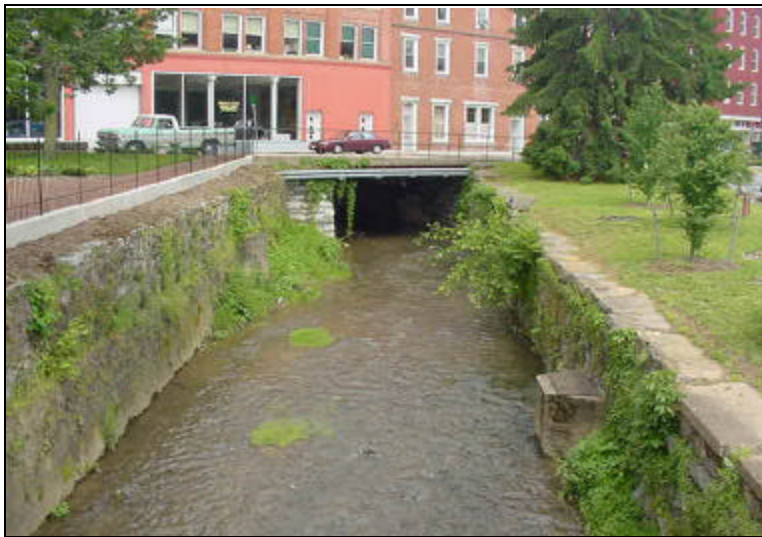
**Severe:** Hardening and channelization of stream bed.

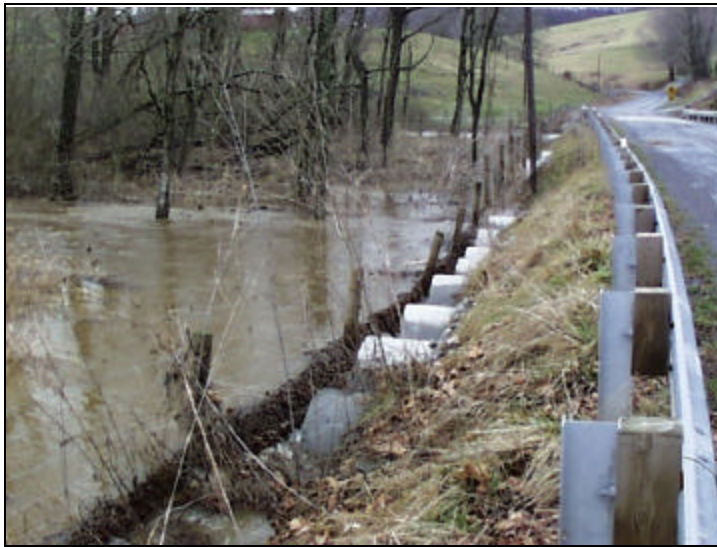
Floodplain culverts are encouraged and may be assessed as a minimization measure or compensation for other impacts on the same stream in the vicinity of the bridge at the agency personnel's discretion.

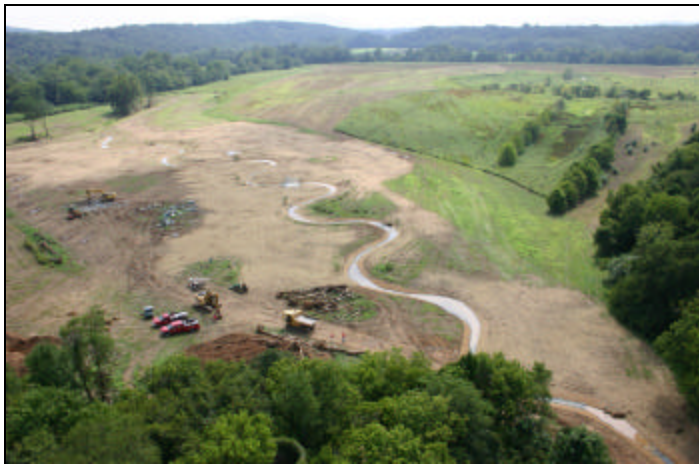
**Priority 1 Restoration:** This stream was relocated and reconnected to its floodplain using reference reach info to design proper dimension, pattern, and profile.

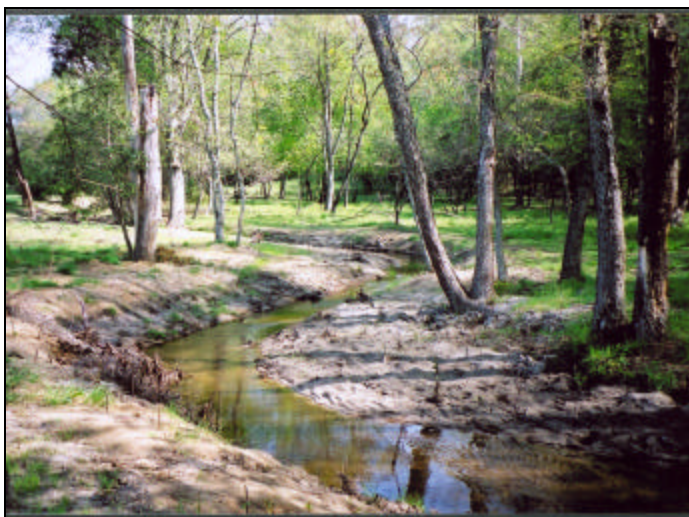
**Priority 1 Restoration:** This stream was relocated and reconnected to its floodplain using reference reach info to design proper dimension, pattern, and profile.

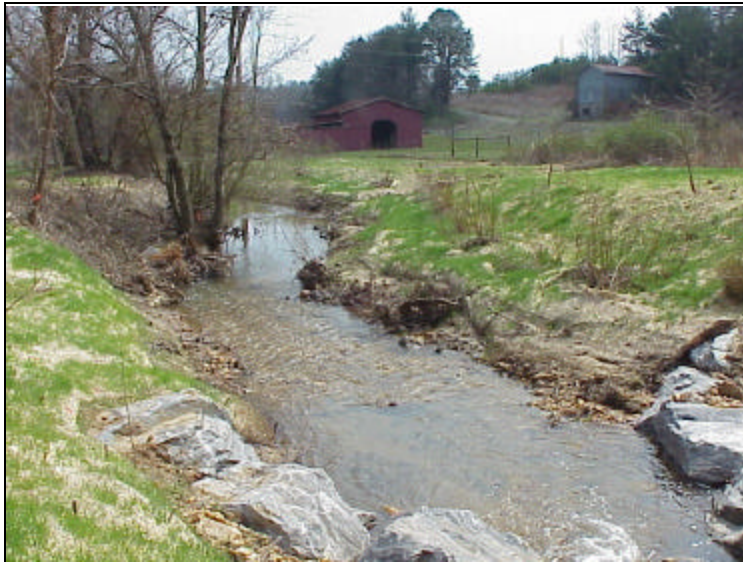
**Enhancement with Instream Structures, Creating Bankfull Benches, and Streambank Planting:** This project improved the channel profile and cross-section through installing grade control structures and creating a bankfull bench.

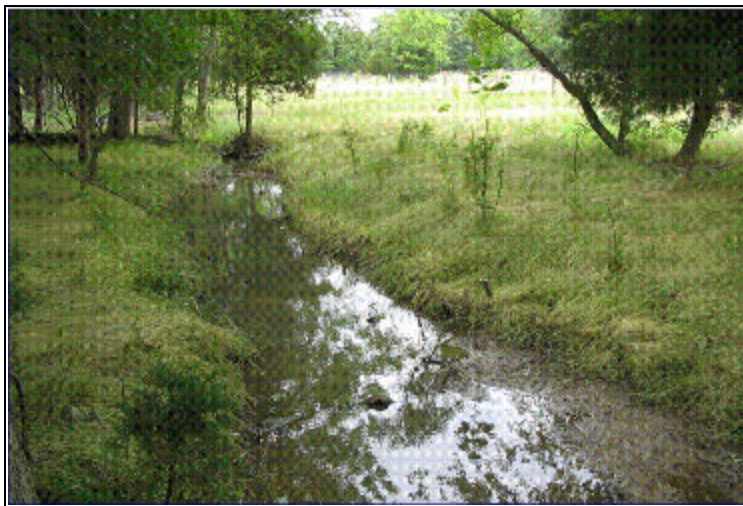
**Lay Back Banks, Bioremediation Techniques and Streambank Planting:** This project Improved stream bank stability by laying back the banks, installing coir logs, and planting the banks.

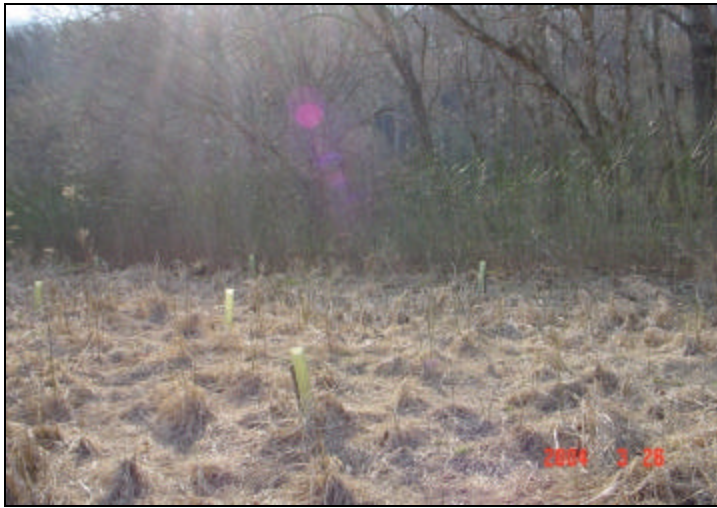
Riparian buffer planting.
